Manhole Inspection Summary

Manhole # S17AA_037MH

Insp Date: **4/13/09 2:30 PM**

Location Address: **901 WARWICK AVE**

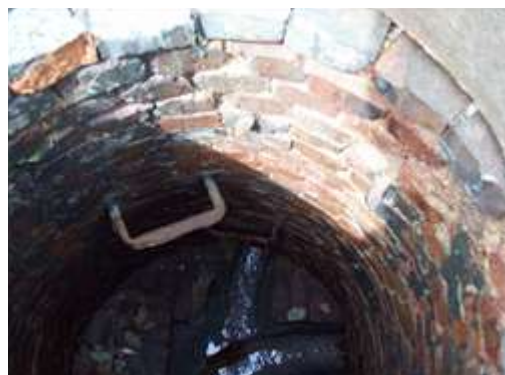
Defect 3

Steps Count: **3** Missing: **0** ☒ **Corroded**

CORRODED STEPS

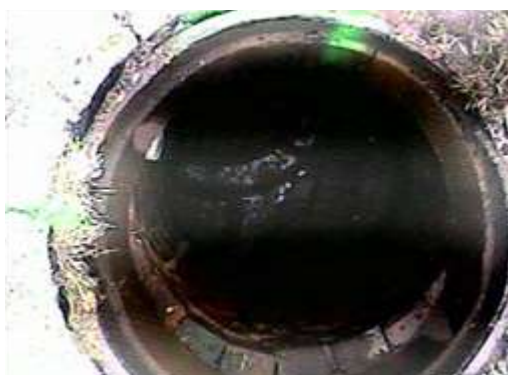
Defect 2

Frame Offset: **4** (in.) Condition: ☐ Sound ☒ **Cracked** ☐ Leaks

Condition: ☐ Sound ☐ Cracked ☐ Root Intrusion ☐ Loose Brick ☒ **Deteriorated**

FRAME OFFSET/DETERIORATED
CHIMNEY

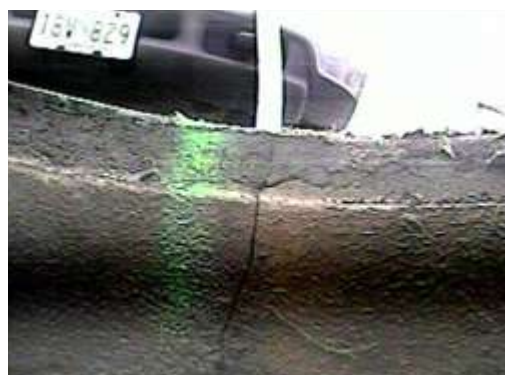
Defect 1

Comments **SEAL AROUND FRAME IS LOOSE AND SEVERED.**

FRAME CRACKED

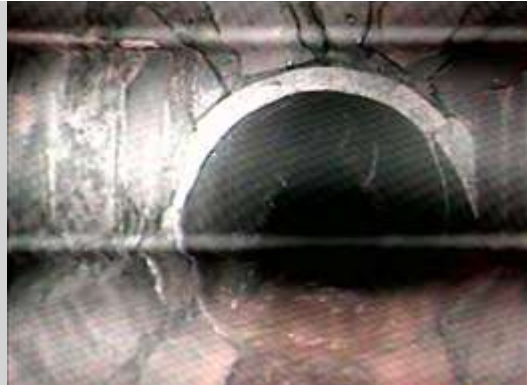
12 O'Clock Outflow

8 in. Circular Gravity Sewer
Pipe Out @ 12 O'Clock

Infiltration: **None** Pipe Seal Cond: **Sound**

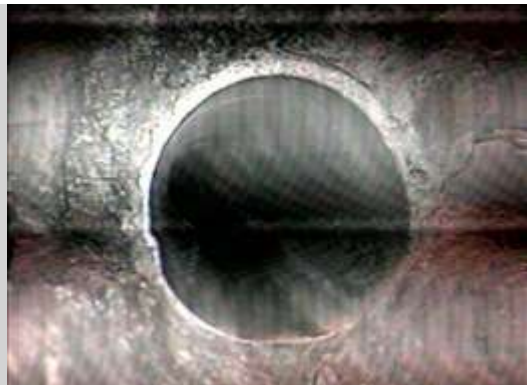
6 O'Clock Inflow

8 in. Circular Gravity Sewer
Pipe In @ 6 O'Clock

Infiltration: **None** Pipe Seal Cond: **Sound**

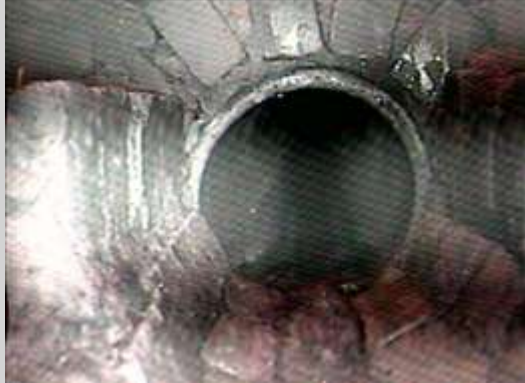
9 O'Clock Inflow

8 in. Circular Gravity Sewer

Pipe In @ 9 O'Clock

Infiltration: **None** Pipe Seal Cond: **Sound**
